## PROSIDING XXVII DAN KONGRES X PERHAPI 2018

### GROUND DEFORMATION MONITORING BY CONVERGENCE MEASUREMENT AND DAMAGED AREA MAPPING IN DEEP ORE ZONE (DOZ) MINE AT PT. FREEPORT INDONESIA

**ANDRE SEBASTIANO GINTING and HADNALTIAS ALPEKI** Underground  
Geotechnical and Hydrology Department, PT Freeport Indonesia, Tembagapura,  
Indonesia

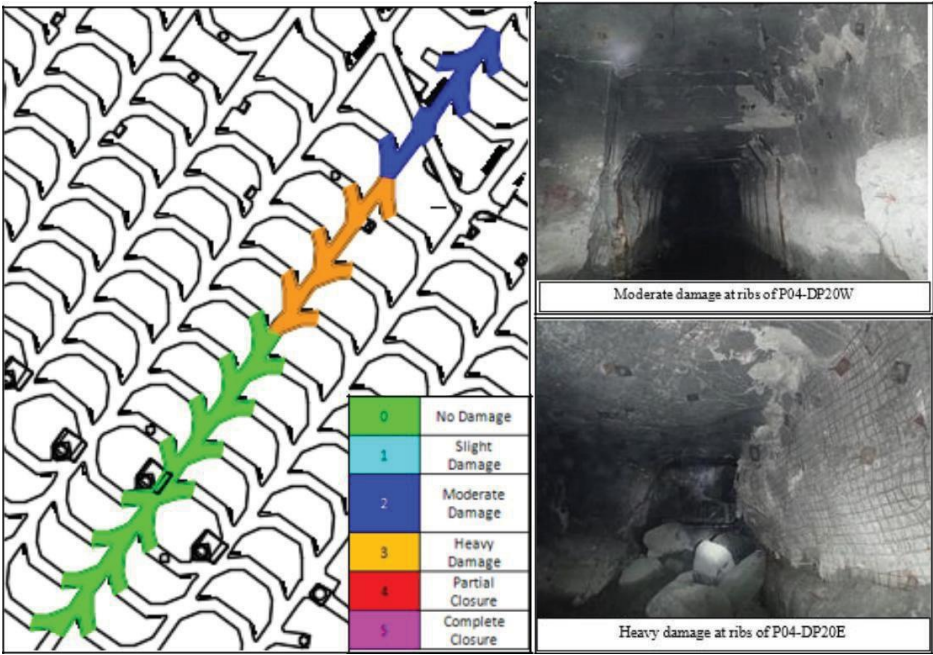
Figure 1. Damage Map of Panel 04 DP15E-DP20E

The moderate damage was observed at Panel 04 DP15E-DP17W, while the heavy damage was observed at Panel 04 DP18E-DP20E. The concern ground is located on heavy damage area, this area will be the first conducted rehabilitation.

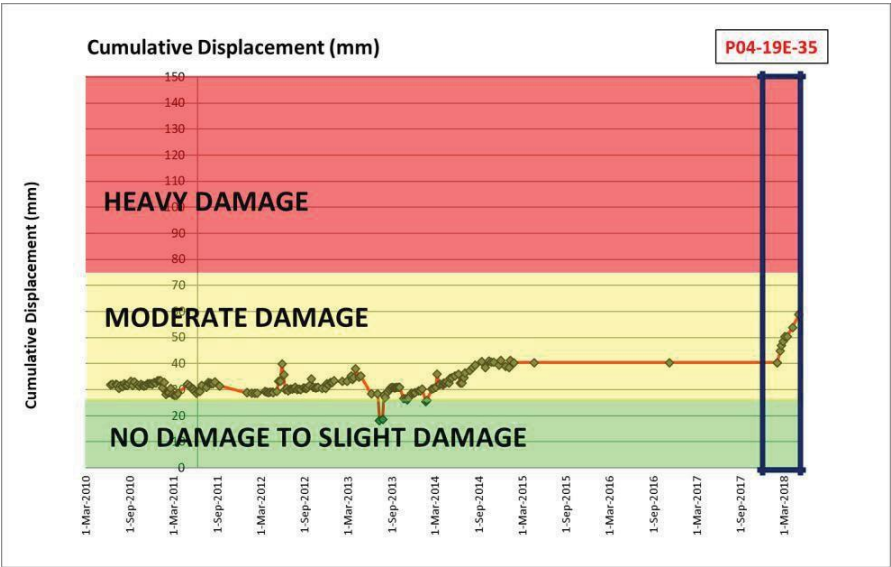
Graph 1. Cummulative Displacement of Panel 04 DP19E

Convergence measurement shows the displacement of two ribs in a drawpoint. The significant values of displacement is 1.0 mm/day. If this value is recorded, it needs to compare with other monitoring data to ensure the significant value is no mistake or human error. The other monitoring data are ZF Laser Scan and uGPS.

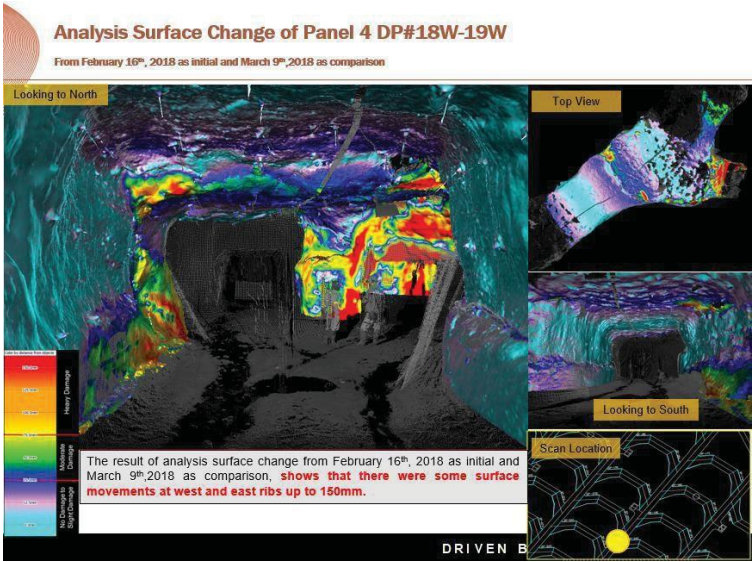
Figure 3. ZF Scan Result of Panel 04 DP18W-DP19W

The ground displacement by convergence measurement is need to compare with ZnF Scan to show that the displacement is not mistaken by mechanical or human error. By ZnF Scan, it shows the exactly moving part of ground.

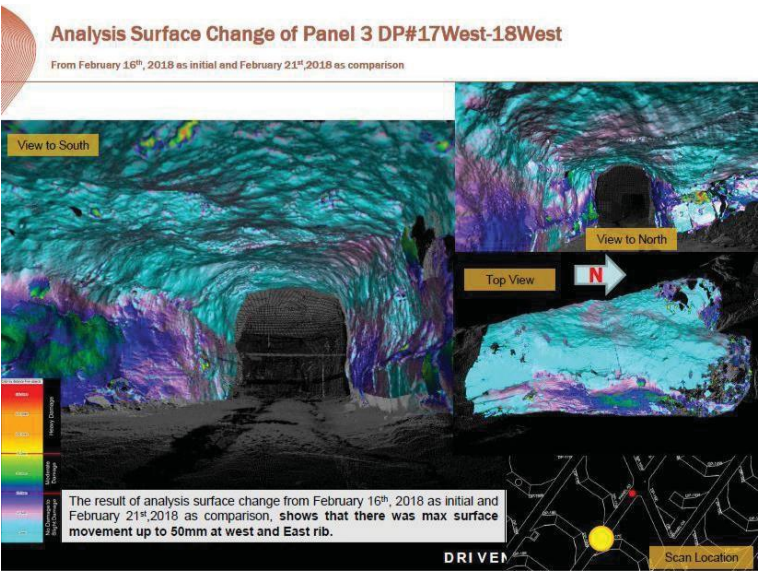
Figure 5. ZnF Scan Result of Panel 03

Based on ZF Laser Scan result on Panel 03 DP17W-DP18W, there was max surface movement up to 50 mm at west and east rib ground. It supports to convergence value recorded that there was a displacement in this area.

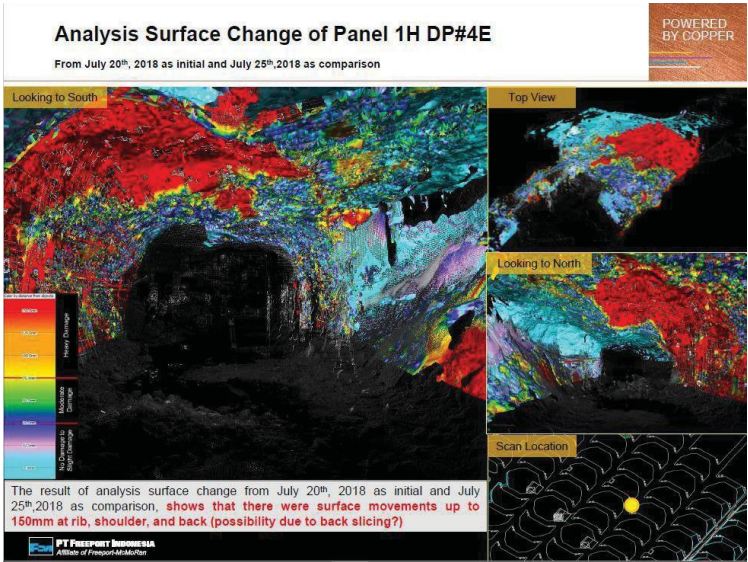
Figure 6. ZF Laser Scan Result of Panel 1H

Based on ZF Laser Scan result on Panel 1H DP02E-DP06W, there was max surface movement up to 50 mm at rib, shoulder, and back of ground. It supports to convergence value recorded that there was a displacement in this area.

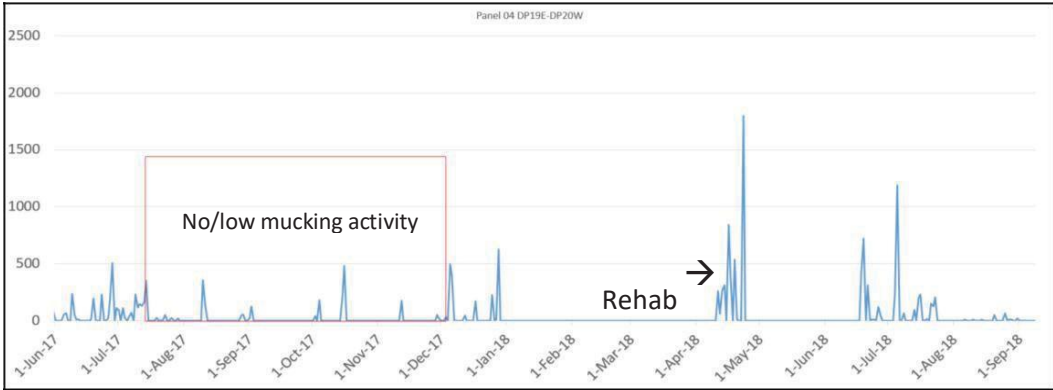
Graph 4. Mucking Activity at Panel 04

mostly caused static load which It has related to no mucking activity on the drawpoint. Based on mucking activity data and time of rehab, damage and significant displacement found after no mucking activity for long time, such as the graphs as below.
